TYPICAL DETAIL @ CHEEK WALL

ASK12

ENLARGED ROOF PLAN @ NORTHWEST VALLEY & PHOTO KEY

RESTORATION OF EAVE CONDITION ABOVE 2ND FLOOR WINDOW

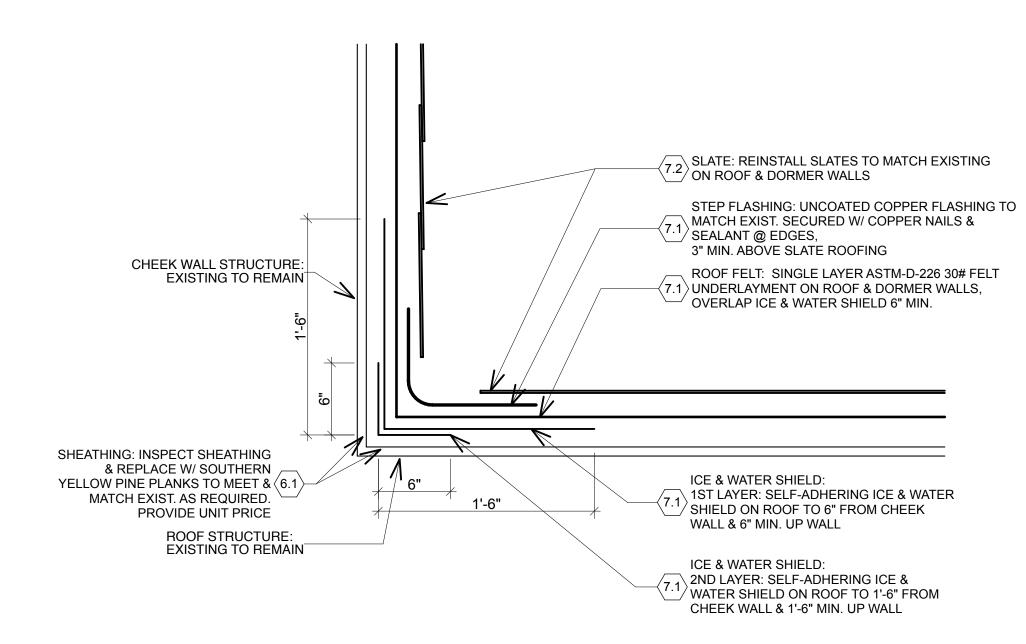
REMOVE SLATE @ LOW END OF VALLEY.
REMOVE DAMAGED PORTION OF COPPER

VALLEY FLASHING. (2.3)

NOTE: ROOF SLATES TO BE SALVAGED & REINSTALLED WHERE POSSIBLE

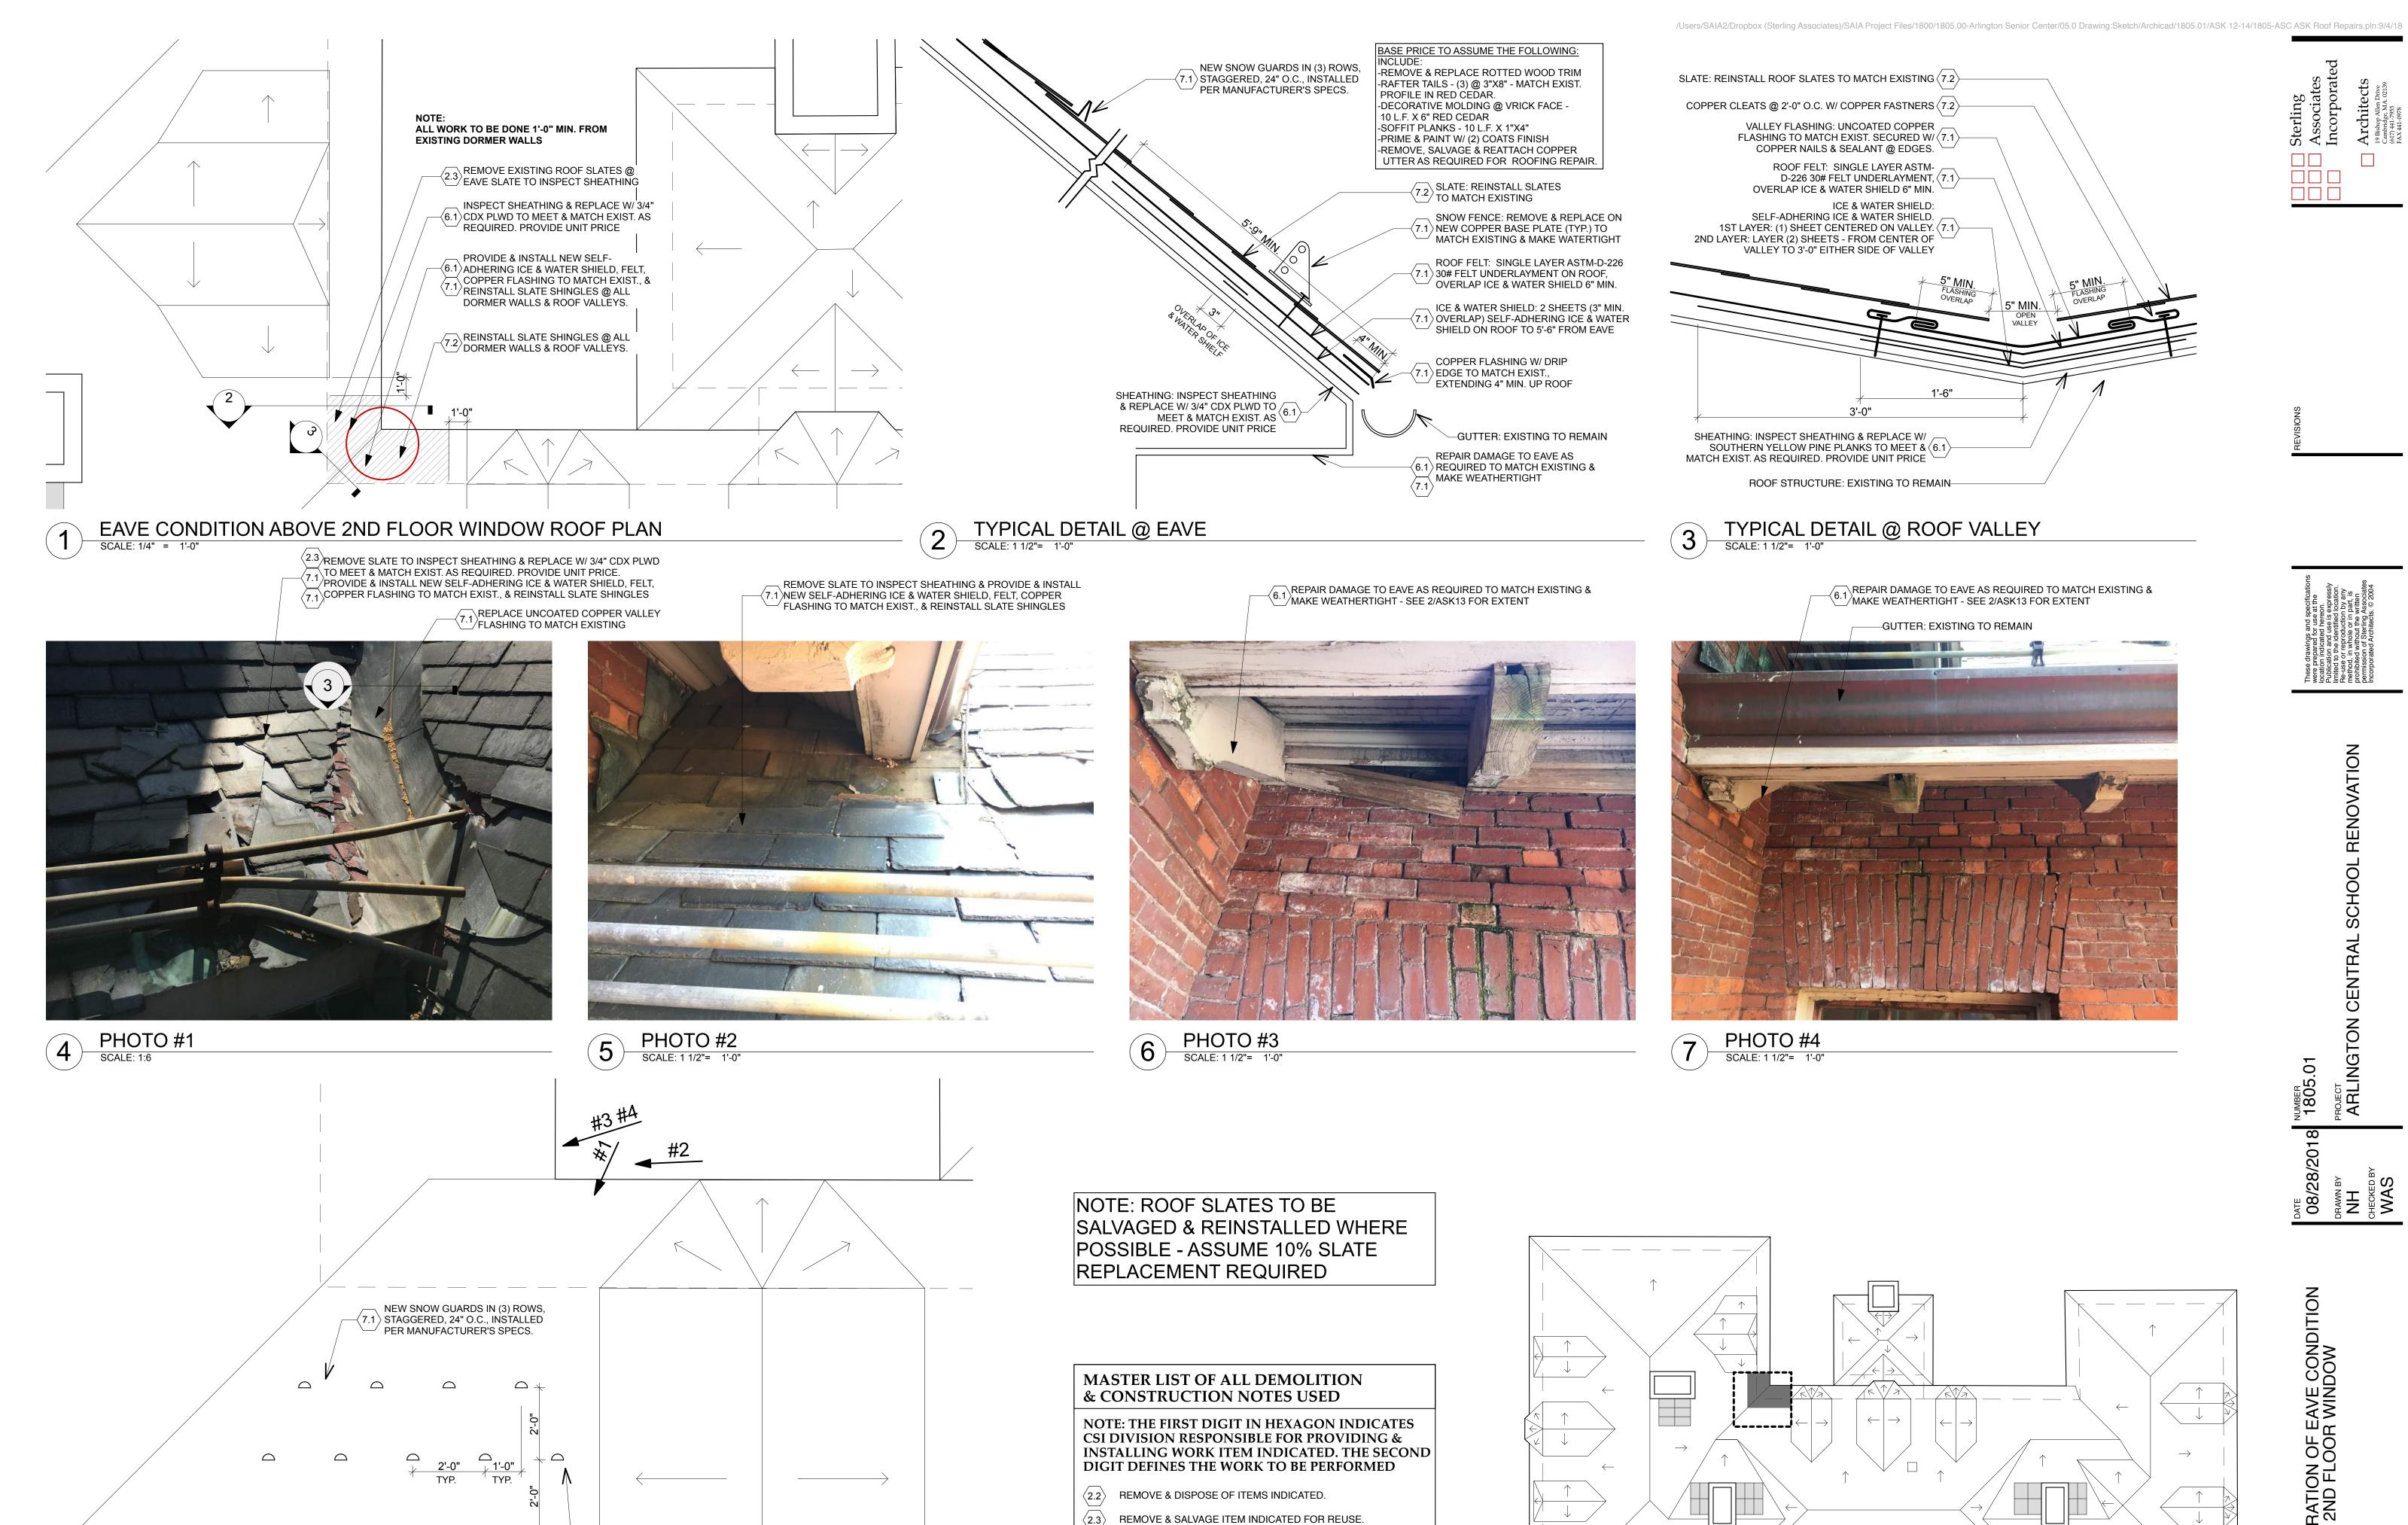
PHOTO #2

DORMER CHEEK WALL & ADJACENT MAIN ROOF

INSPECT SHEATHING & REPLACE W/ SOUTHERN (6.1)
YELLOW PINE PLANKS TO MEET & MATCH EXIST. AS REQUIRED. PROVIDE & INSTALL NEW SELF-ADHERING ICE & $\sqrt{7.1}$ WATER SHIELD, FELT, COPPER FLASHING TO MATCH EXIST., & REINSTALL SLATE SHINGLES (7.2) REMOVE SLATE @ THIS DORMER CHEEK WALL & 1 COURSE (MIN.) OF SLATE @ ADJACENT MAIN ROOF. REMOVE COPPER STEP FLASHING. 2.3 INSPECT SHEATHING & REPLACE W/ SOUTHERN (6.1) YELLOW PINE PLANKS TO MEET & MATCH EXIST. AS REQUIRED. PROVIDE & INSTALL NEW SELF-ADHERING ICE & WATER SHIELD, FELT, COPPER FLASHING TO MATCH(7.1)EXIST., & REINSTALL SLATE SHINGLES @ THIS 7.2
